City of Moore
Infrastructure Recovery and Implementation Plan
 Infrastructure Assessment Form

Assessment Area Rock Creek
Assessment Sub-Area RC2
Infrastructure Category Sidewalks
Exhibit Group E.2

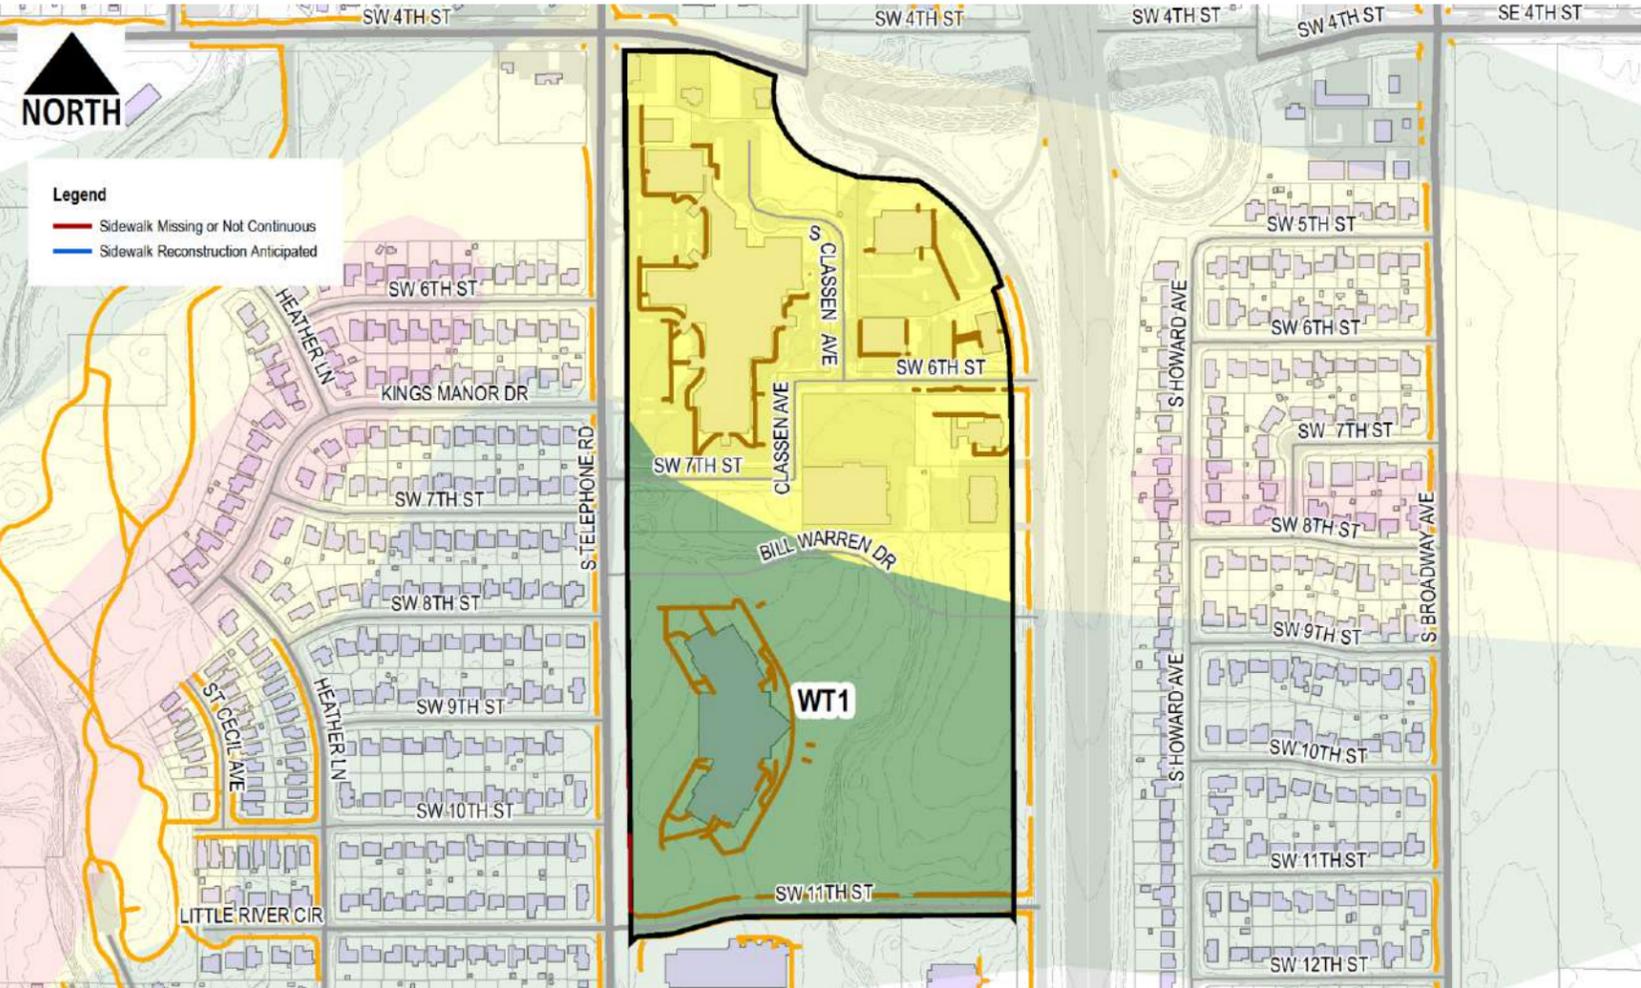
Key Map

Description	Value	Fraction of Historical Length	Weighting Factor	Score
Length within EF4 to EF5 Damage Area prior to disaster (ft)	0	0.00	10.00	0.00
Length within EF2 to EF4 Damage Area prior to disaster (ft)	4269	0.46	5.00	2.32
Length within EF0 to EF2 Damage Area prior to disaster (ft)	4928	0.54	2.00	1.07
Length Outside Damage Area prior to Disaster (ft)	0	0.00	1.00	0.00
Damage Score				3.39

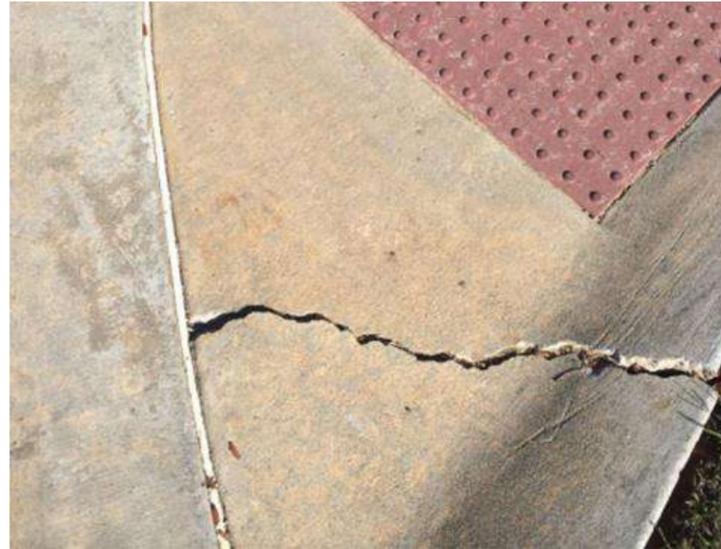
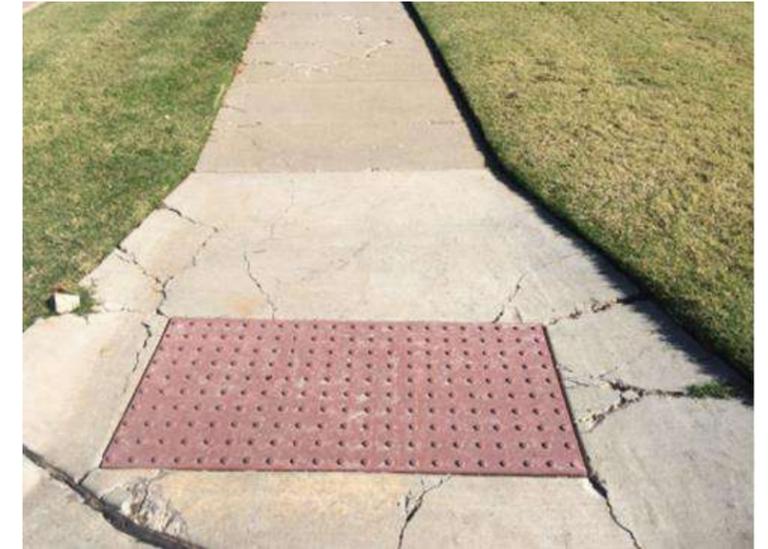
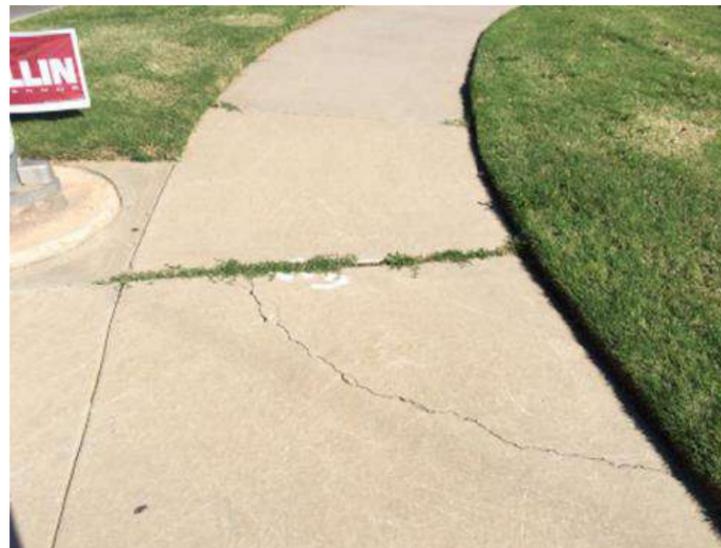
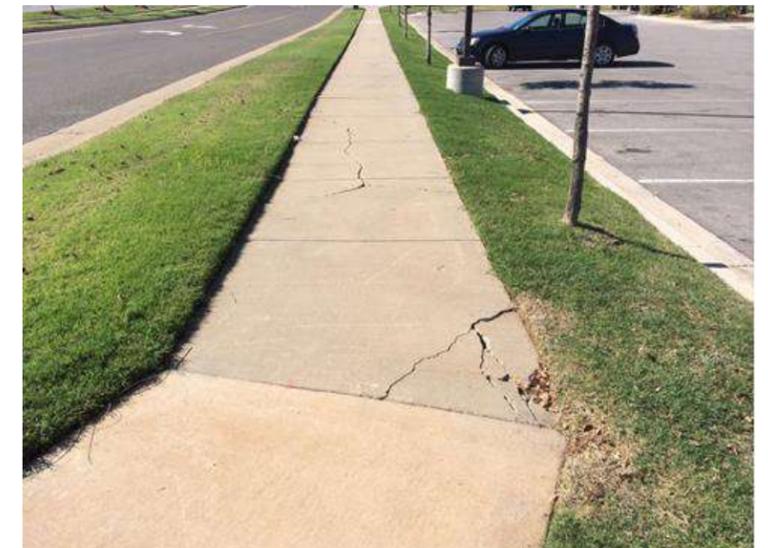
Infrastructure Photographs

Description	Quantity	Weighting Factor	Score	Description	Quantity	Weighting Factor	Score
SW1 - surface spall	0	0.25	0.00	SW8 - longitudinal slope > 5%	0	0.25	0.00
SW2 - joint deflection	1	0.25	0.25	SW9 - cross slope > 2%	0	0.25	0.00
SW3 - panel settlement	0	0.25	0.00	SW10 - evidence of ponding	0	0.25	0.00
SW4 - panel cracking	13	0.25	3.25	SW11 - anticipated future damage	0	0.25	0.00
SW5 - obstructions present	0	0.25	0.00	SW12 - evidence of recent repair work	0	0.25	0.00
SW6 - curb ramps not present	0	0.25	0.00	SW14 - insufficient vehicular separation	0	0.25	0.00
SW7 - sidewalk missing or not continuous	1	0.25	0.25	SW15- not ADA compliant at intersection	3	0.25	0.75
Condition Score							4.50

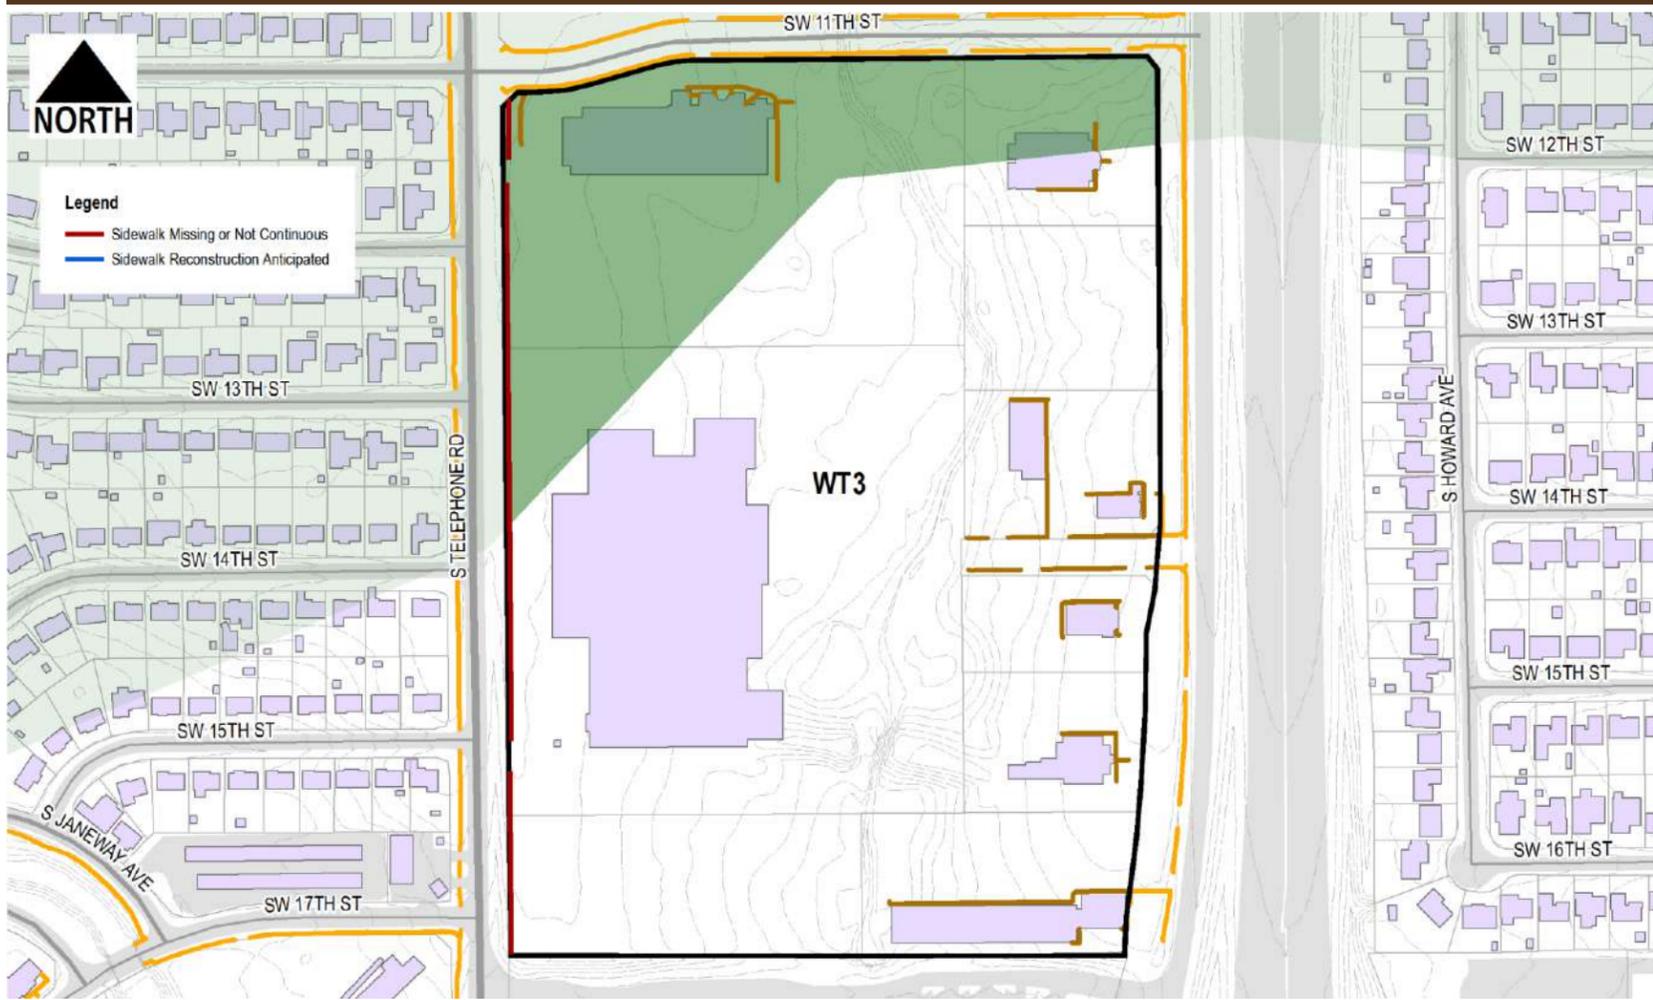
Key Map

Description	Value	Fraction of Historical Length	Weighting Factor	Score
Length within EF4 to EF5 Damage Area prior to disaster (ft)	0	0.00	10.00	0.00
Length within EF2 to EF4 Damage Area prior to disaster (ft)	0	0.00	5.00	0.00
Length within EF0 to EF2 Damage Area prior to disaster (ft)	505	0.00	2.00	0.00
Length Outside Damage Area prior to Disaster (ft)	2046	0.00	1.00	0.00
Damage Score				0.00

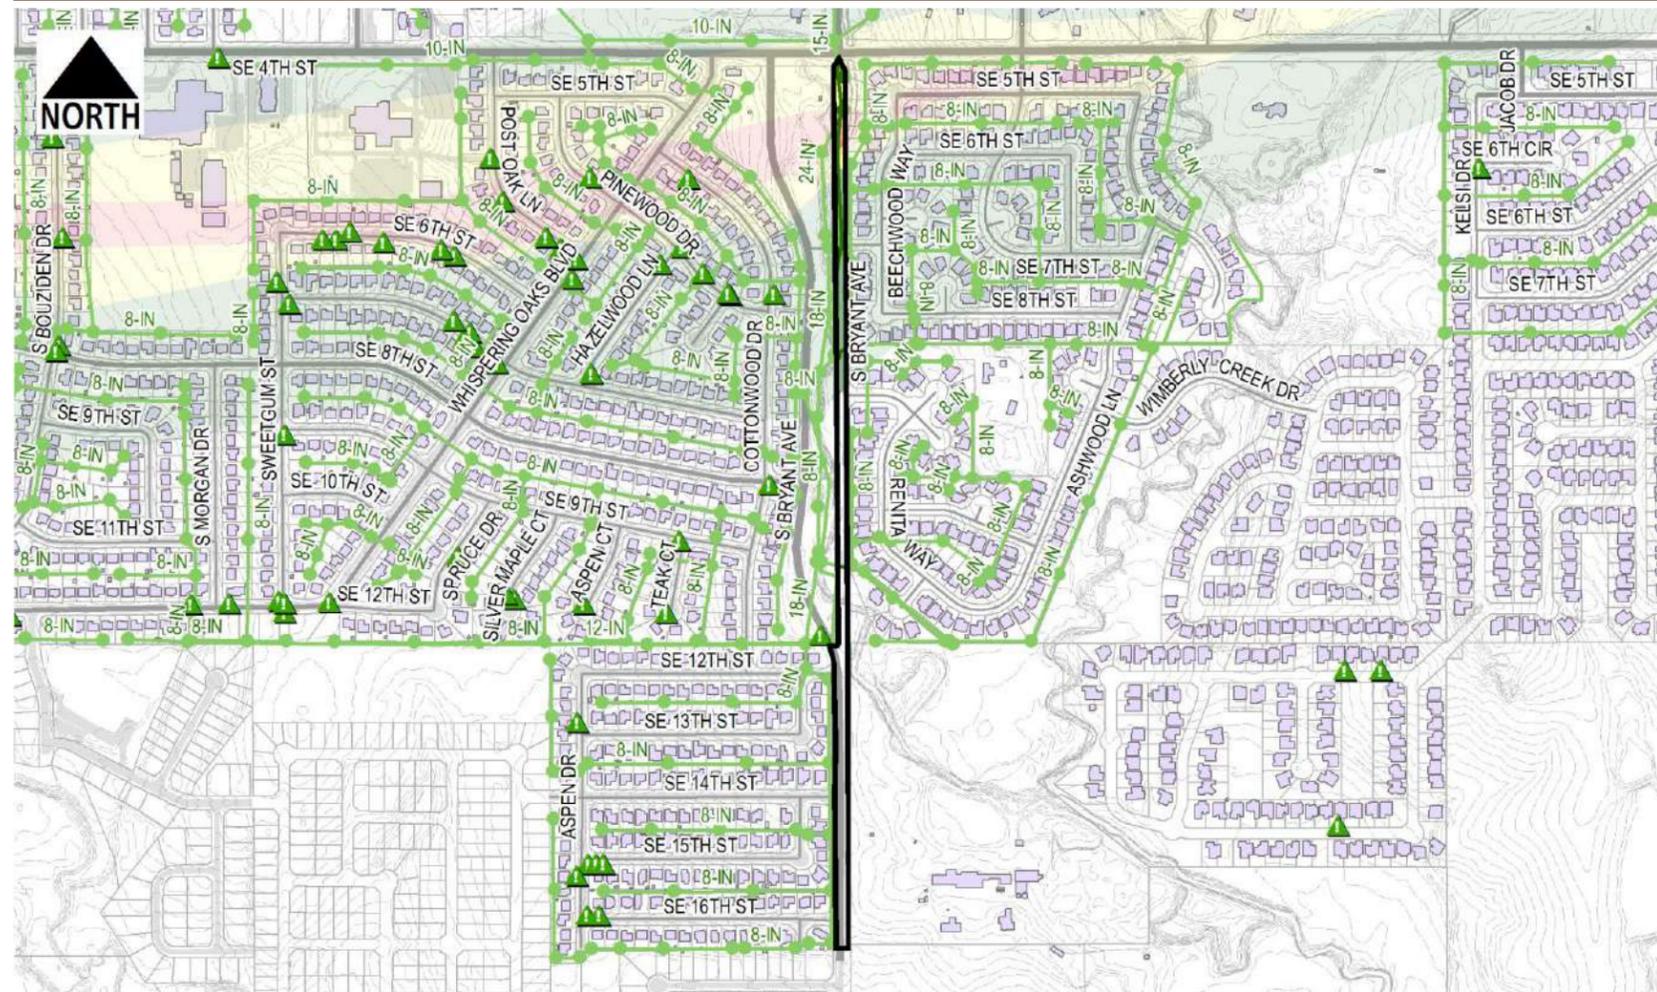
Key Map

Description	Value	Fraction of Historical Length	Weighting Factor	Score
Length within EF4 to EF5 Damage Area prior to disaster (ft)	320	0.19	10.00	1.86
Length within EF2 to EF4 Damage Area prior to disaster (ft)	564	0.33	5.00	1.64
Length within EF0 to EF2 Damage Area prior to disaster (ft)	679	0.39	2.00	0.79
Length Outside Damage Area prior to Disaster (ft)	158	0.09	1.00	0.09

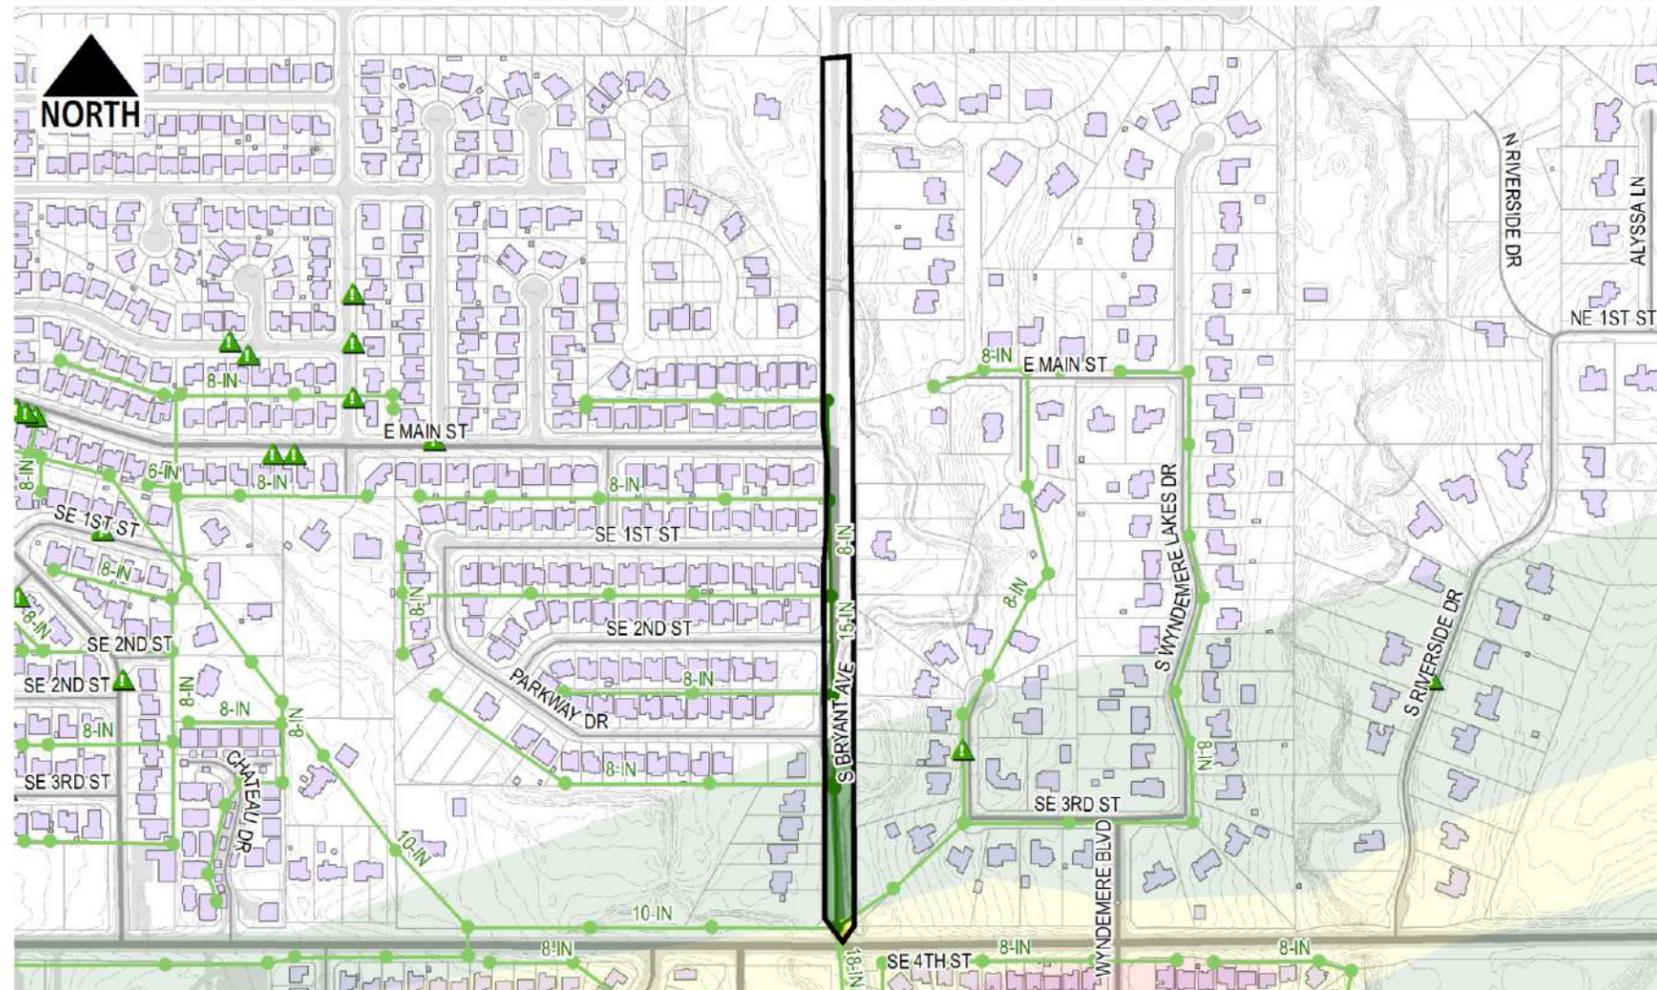
Key Map

Description	Value	Fraction of Historical Length	Weighting Factor	Score
Length within EF4 to EF5 Damage Area prior to disaster (ft)	0	0.00	10.00	0.00
Length within EF2 to EF4 Damage Area prior to disaster (ft)	181	0.10	5.00	0.48
Length within EF0 to EF2 Damage Area prior to disaster (ft)	595	0.32	2.00	0.64
Length Outside Damage Area prior to Disaster (ft)	1089	0.58	1.00	0.58

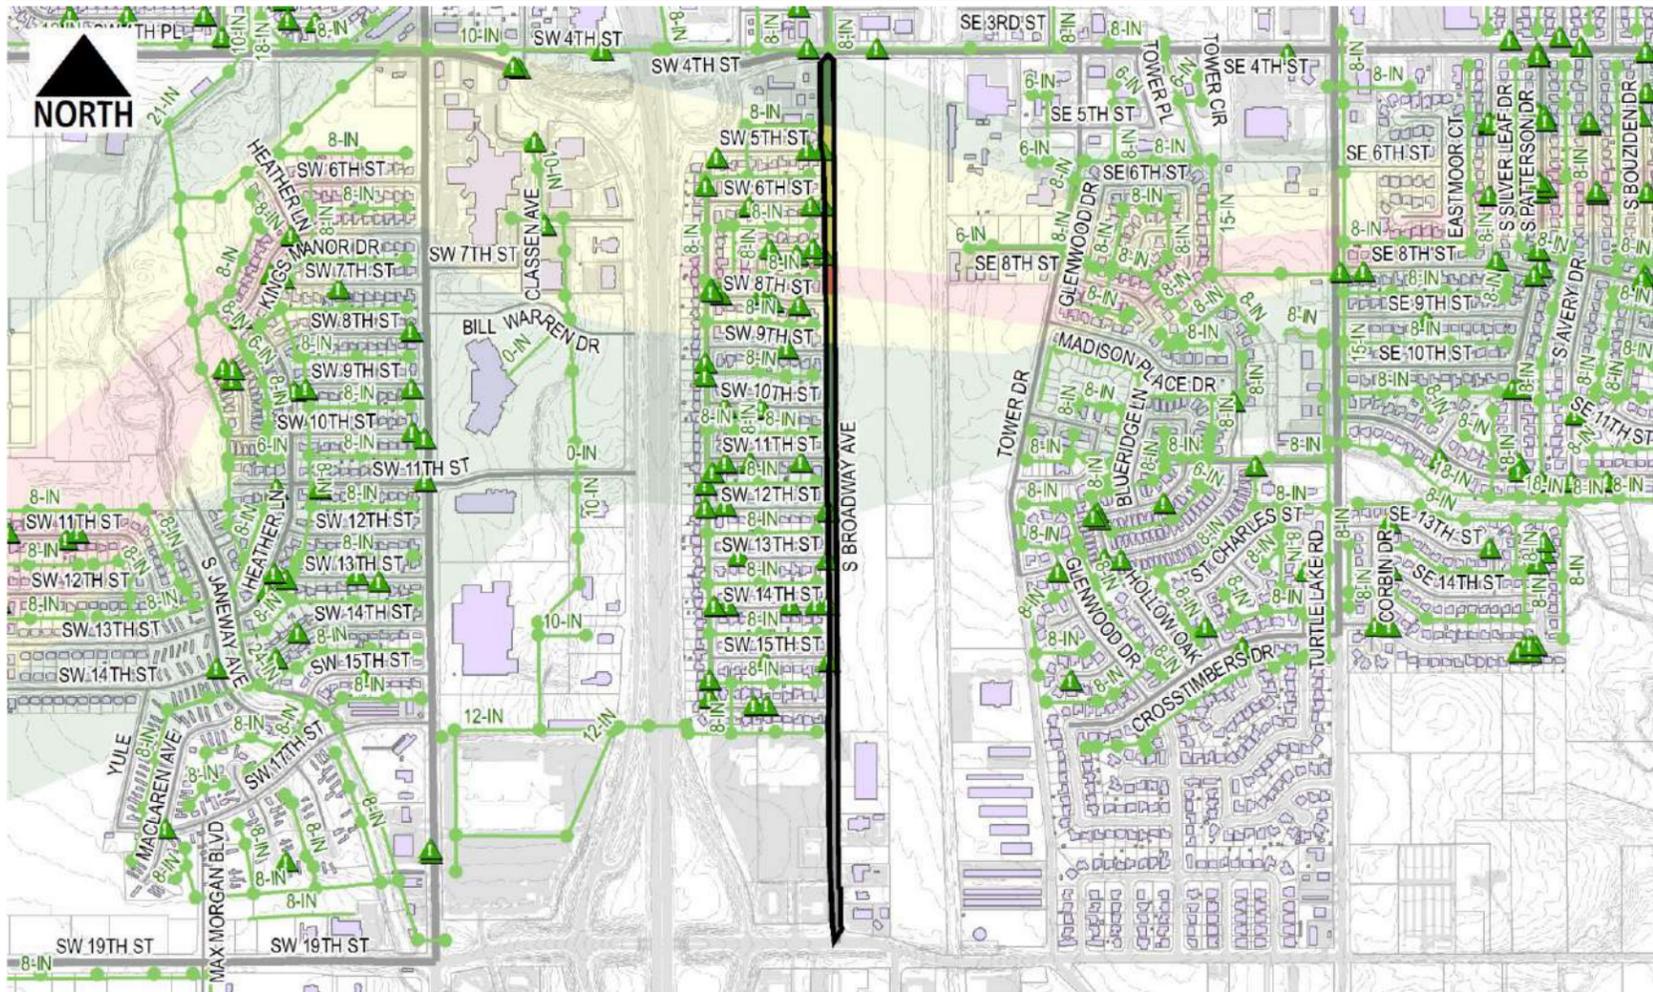
Key Map

Description	Value	Fraction of Historical Length	Weighting Factor	Score
Length within EF4 to EF5 Damage Area prior to disaster (ft)	0	0.00	10.00	0.00
Length within EF2 to EF4 Damage Area prior to disaster (ft)	0	0.00	5.00	0.00
Length within EF0 to EF2 Damage Area prior to disaster (ft)	0	0.00	2.00	0.00
Length Outside Damage Area prior to Disaster (ft)	0	0.00	1.00	0.00
Damage Score				0.00

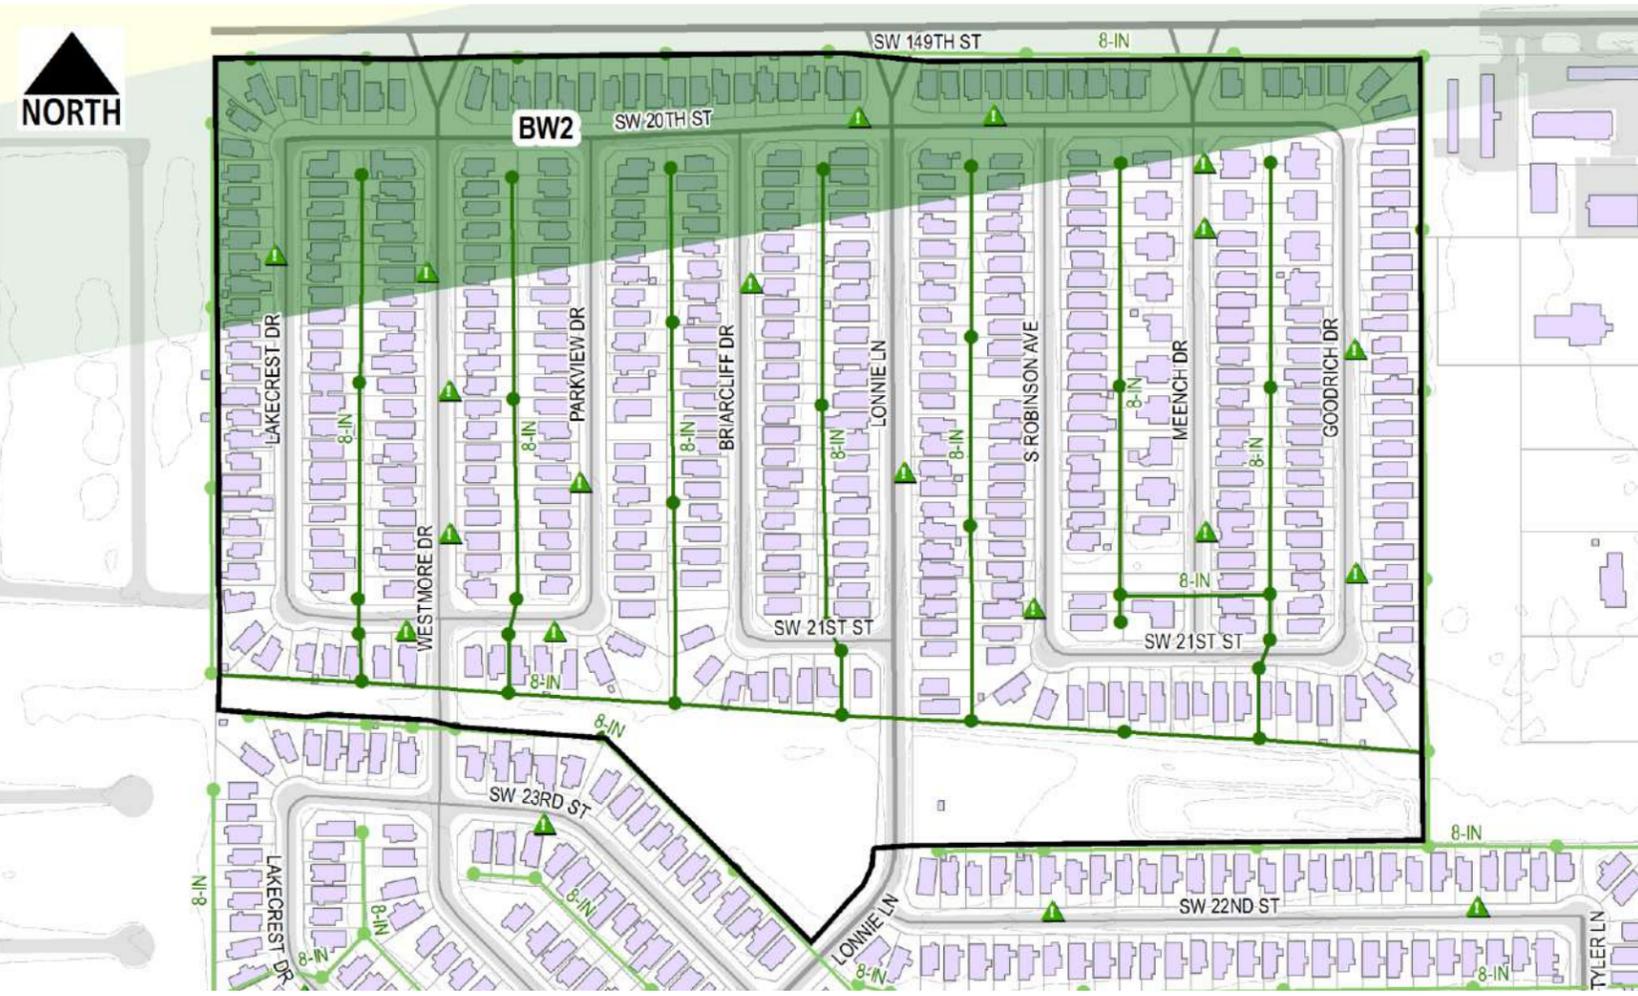
Key Map

Description	Value	Fraction of Historical Length	Weighting Factor	Score
Length within EF4 to EF5 Damage Area prior to disaster (ft)	0	0.00	10.00	0.00
Length within EF2 to EF4 Damage Area prior to disaster (ft)	0	0.00	5.00	0.00
Length within EF0 to EF2 Damage Area prior to disaster (ft)	1863	0.17	2.00	0.34
Length Outside Damage Area prior to Disaster (ft)	9192	0.83	1.00	0.83
Damage Score				1.17

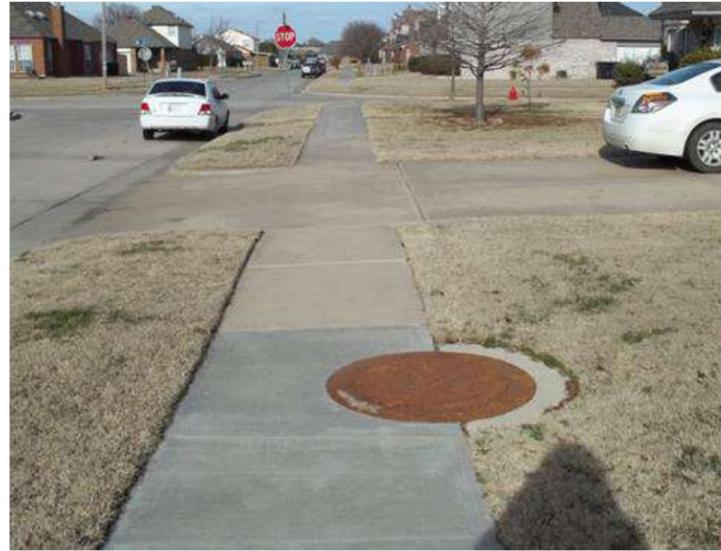
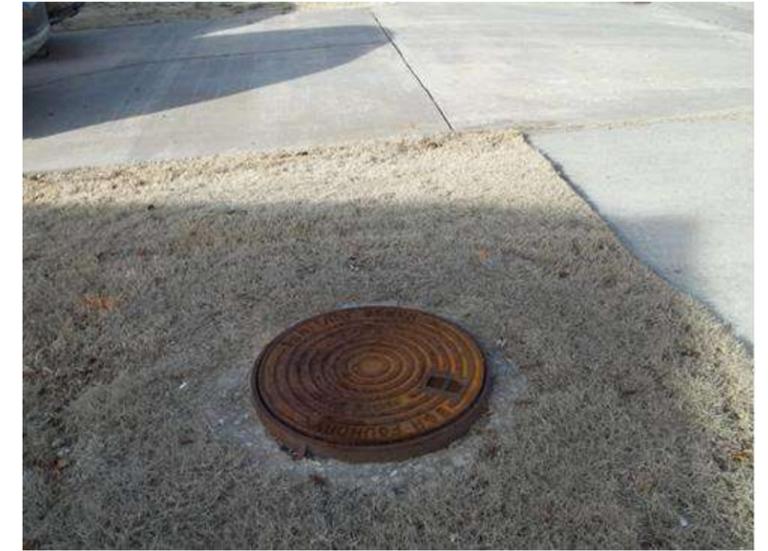
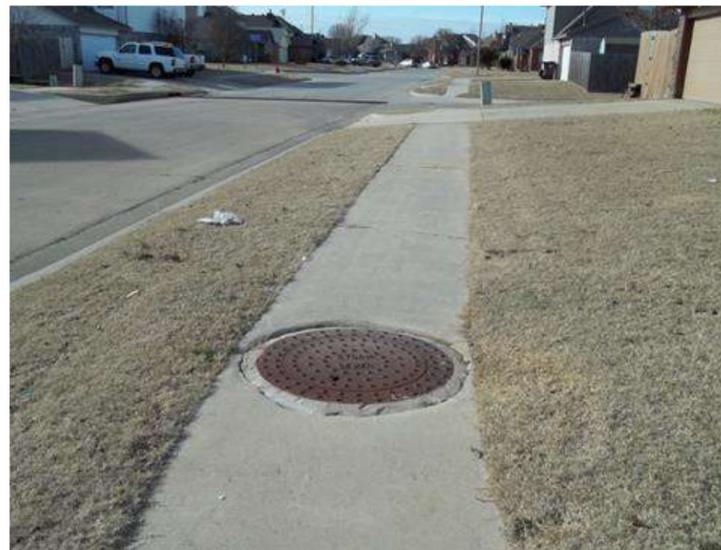
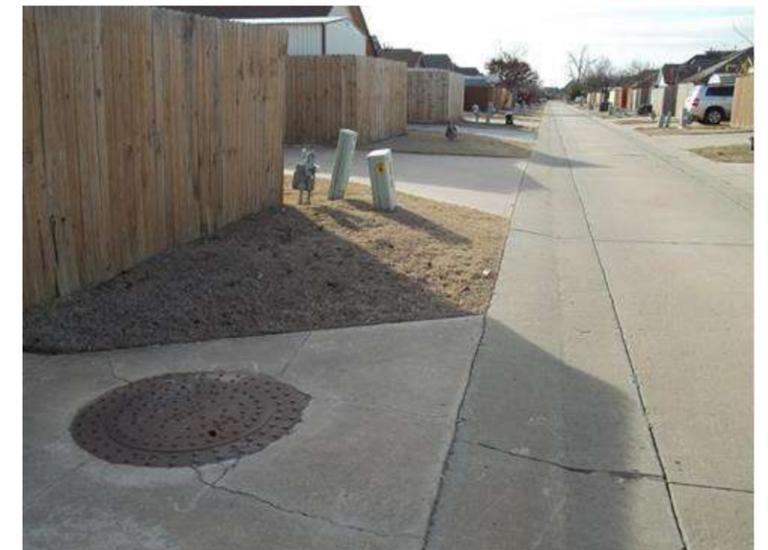
Infrastructure Photographs

Description	Quantity	Weighting Factor	Score
SS1 - Damaged manhole	0	0.25	0.00
SS2 - Brick manhole	0	0.25	0.00
SS3 - Manhole not found	4	0.25	1.00
SS4 - Future service connection anticipated	11	0.25	2.75
SS6 - Maintenance event (2004 - 2014)	20	0.25	5.00
Condition Score			8.75

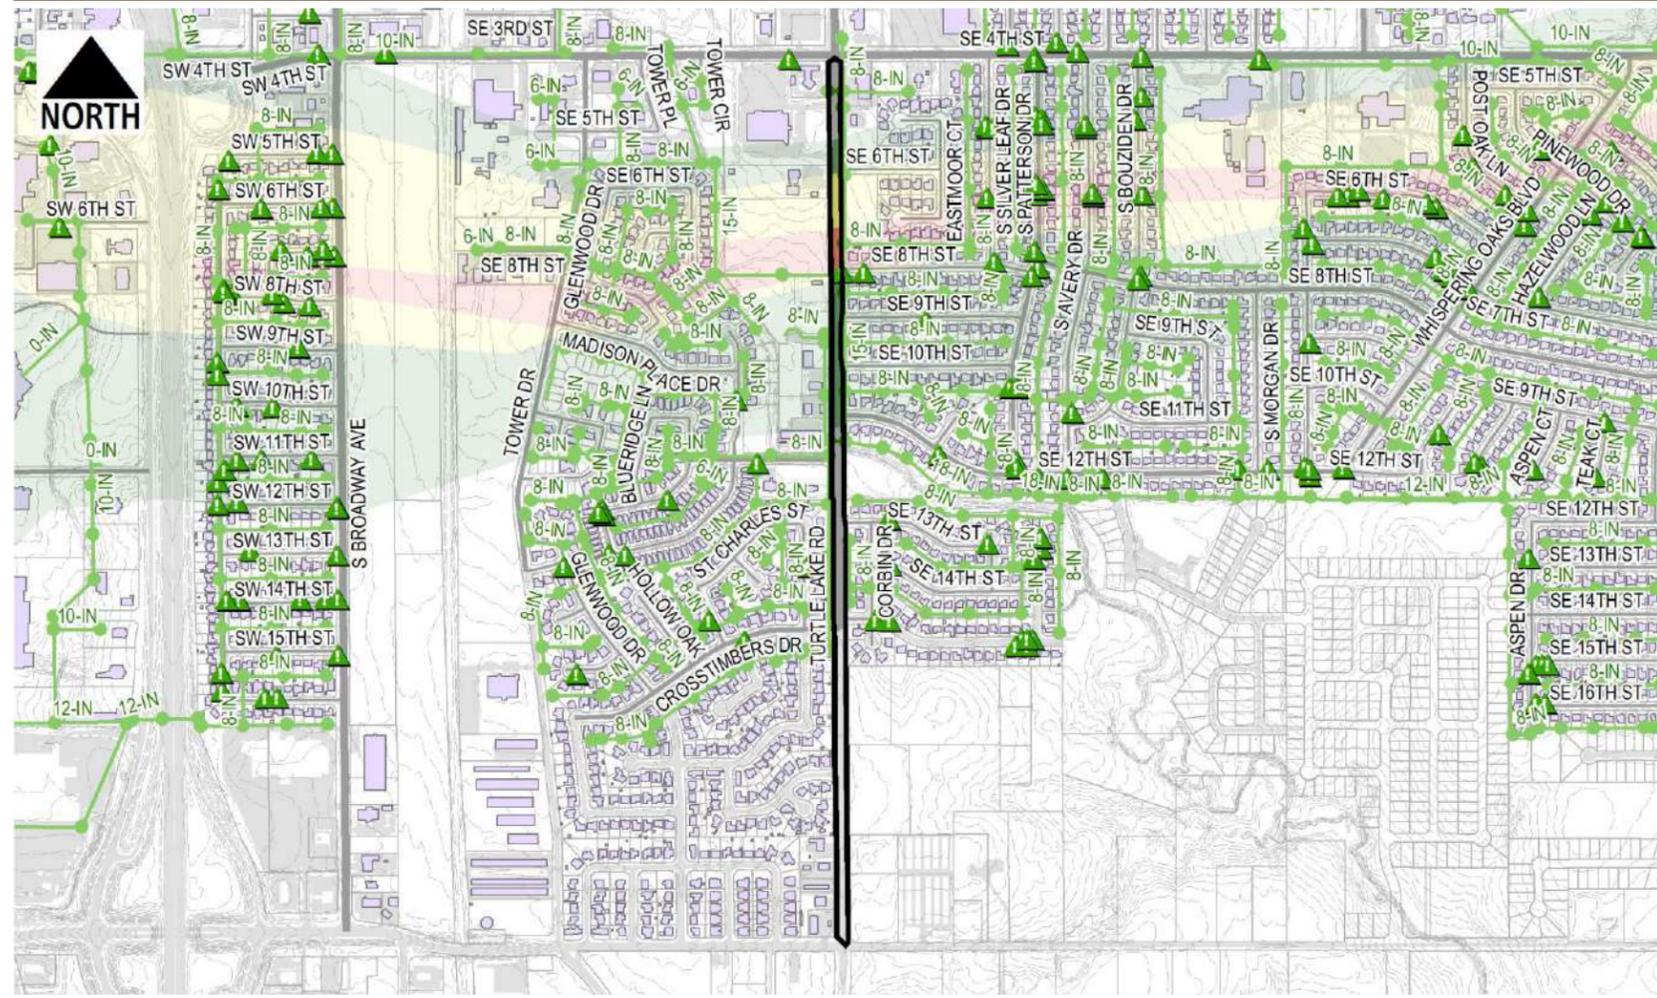
Key Map

Description	Value	Fraction of Historical Length	Weighting Factor	Score
Length within EF4 to EF5 Damage Area prior to disaster (ft)	213	0.17	10.00	1.73
Length within EF2 to EF4 Damage Area prior to disaster (ft)	139	0.11	5.00	0.57
Length within EF0 to EF2 Damage Area prior to disaster (ft)	380	0.31	2.00	0.62
Length Outside Damage Area prior to Disaster (ft)	496	0.40	1.00	0.40

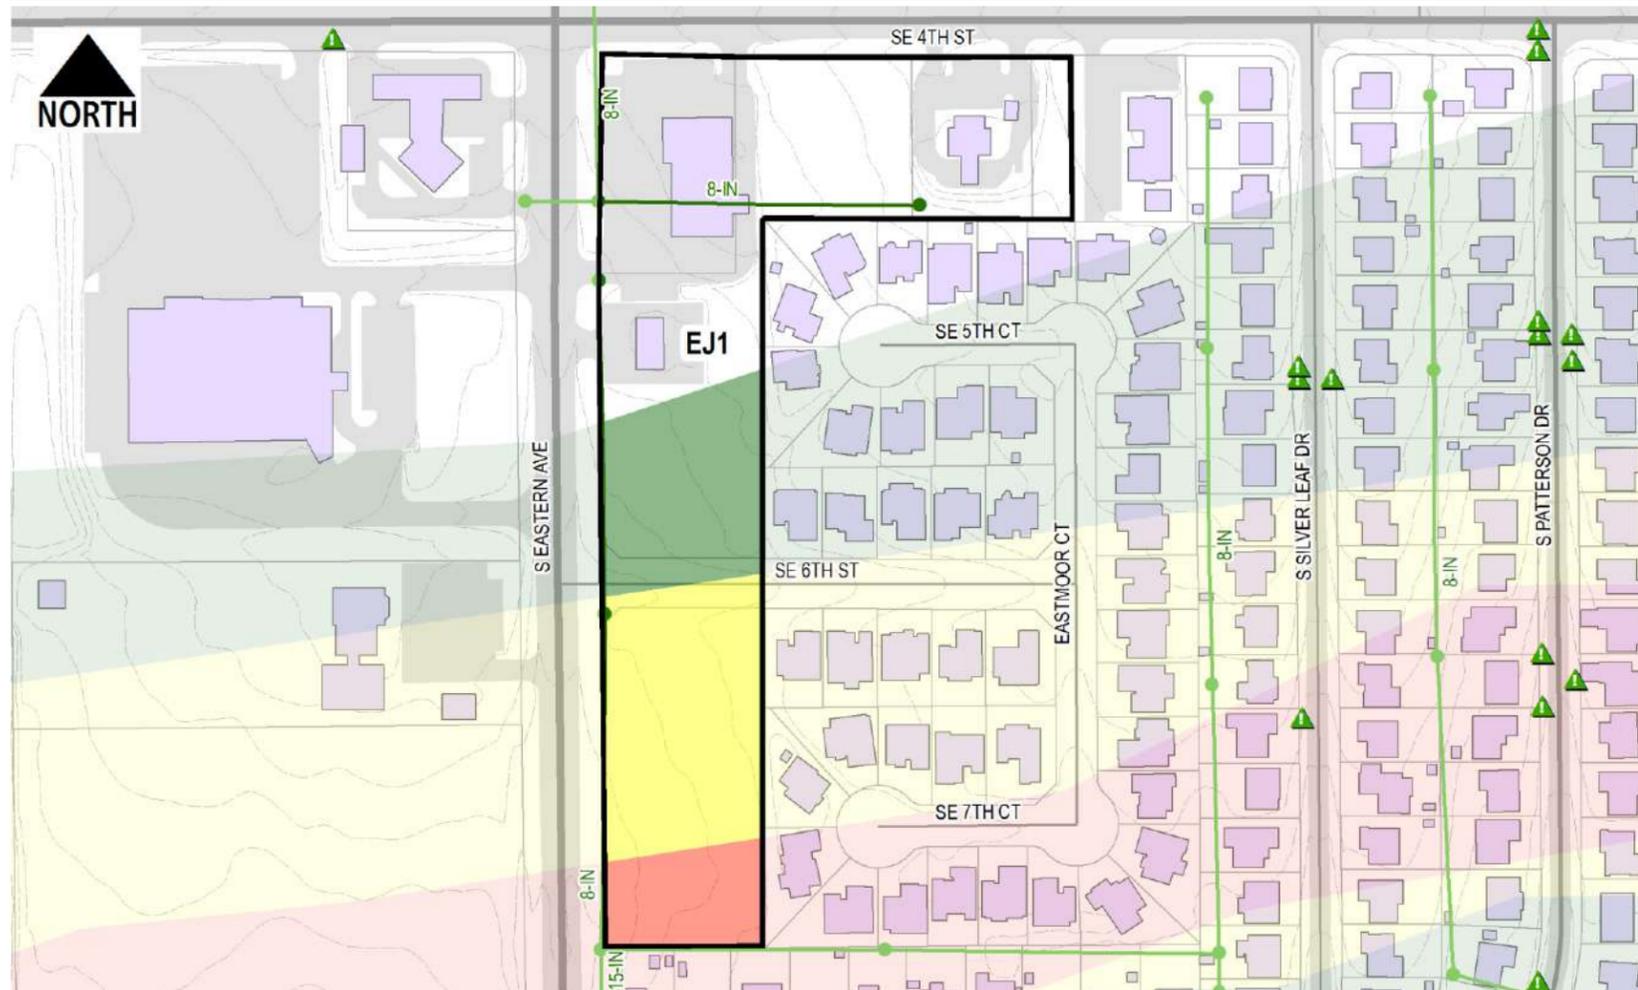
Key Map

Description	Value	Fraction of Historical Length	Weighting Factor	Score
Length within EF4 to EF5 Damage Area prior to disaster (ft)	39	0.03	10.00	0.31
Length within EF2 to EF4 Damage Area prior to disaster (ft)	321	0.26	5.00	1.29
Length within EF0 to EF2 Damage Area prior to disaster (ft)	211	0.17	2.00	0.34
Length Outside Damage Area prior to Disaster (ft)	671	0.54	1.00	0.54
Damage Score				2.49

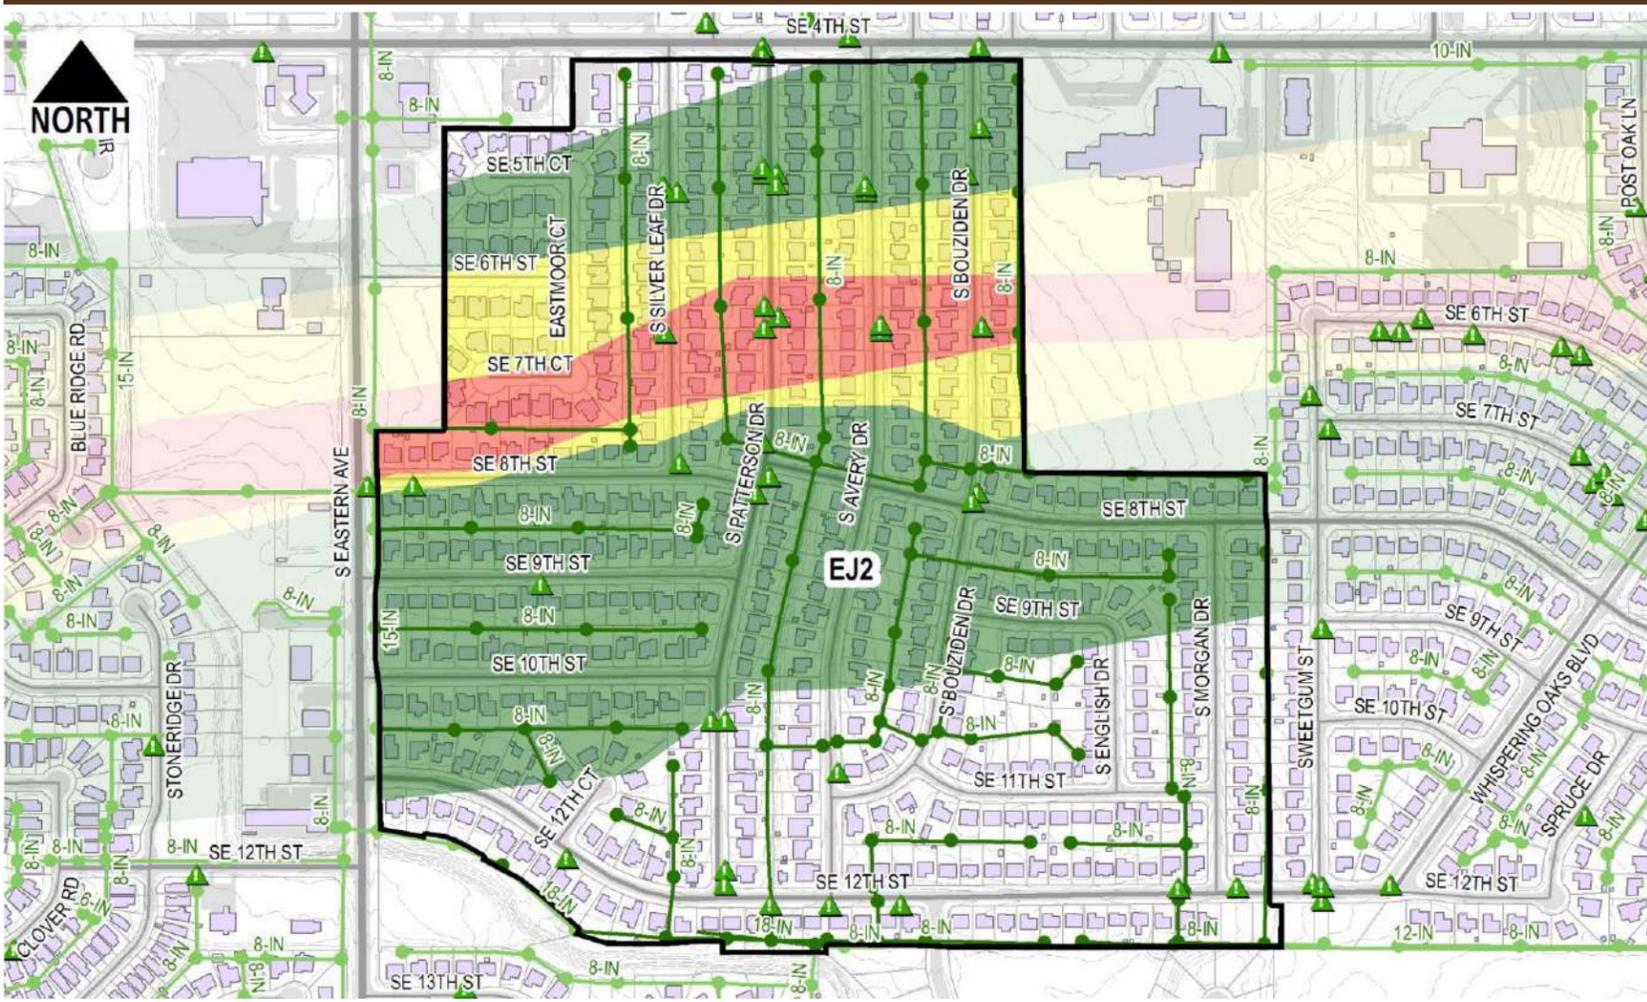
Key Map

Description	Value	Fraction of Historical Length	Weighting Factor	Score
Length within EF4 to EF5 Damage Area prior to disaster (ft)	1961	0.09	10.00	0.86
Length within EF2 to EF4 Damage Area prior to disaster (ft)	1779	0.08	5.00	0.39
Length within EF0 to EF2 Damage Area prior to disaster (ft)	9847	0.43	2.00	0.87
Length Outside Damage Area prior to Disaster (ft)	9128	0.40	1.00	0.40
Damage Score				2.52

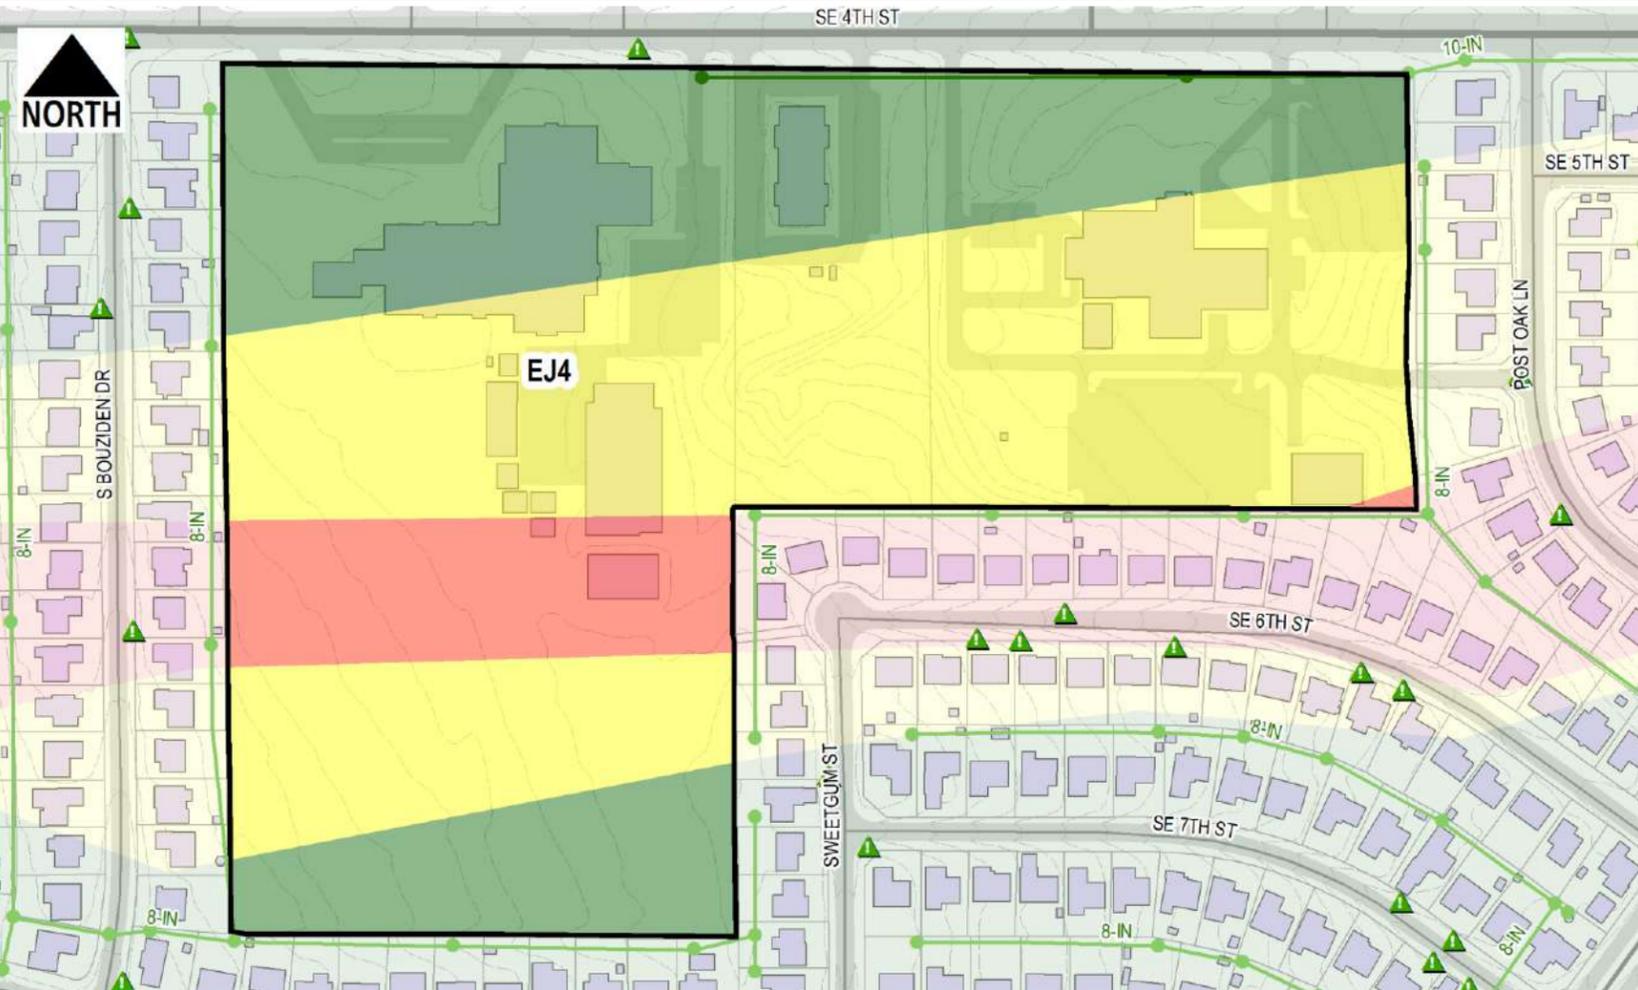
Key Map

Description	Value	Fraction of Historical Length	Weighting Factor	Score
Length within EF4 to EF5 Damage Area prior to disaster (ft)	0	0.00	10.00	0.00
Length within EF2 to EF4 Damage Area prior to disaster (ft)	0	0.00	5.00	0.00
Length within EF0 to EF2 Damage Area prior to disaster (ft)	1043	1.00	2.00	2.00
Length Outside Damage Area prior to Disaster (ft)	0	0.00	1.00	0.00
Damage Score				2.00
